# HISTORIC PRESERVATION RESPONSE METHODOLOGY

Based on the Hurricane Katrina Model

**FEMA**

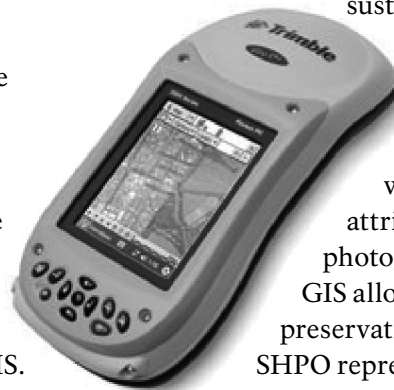
The Trimble GeoExplorer GPS unit used during FEMA's historic preservation response to Katrina.

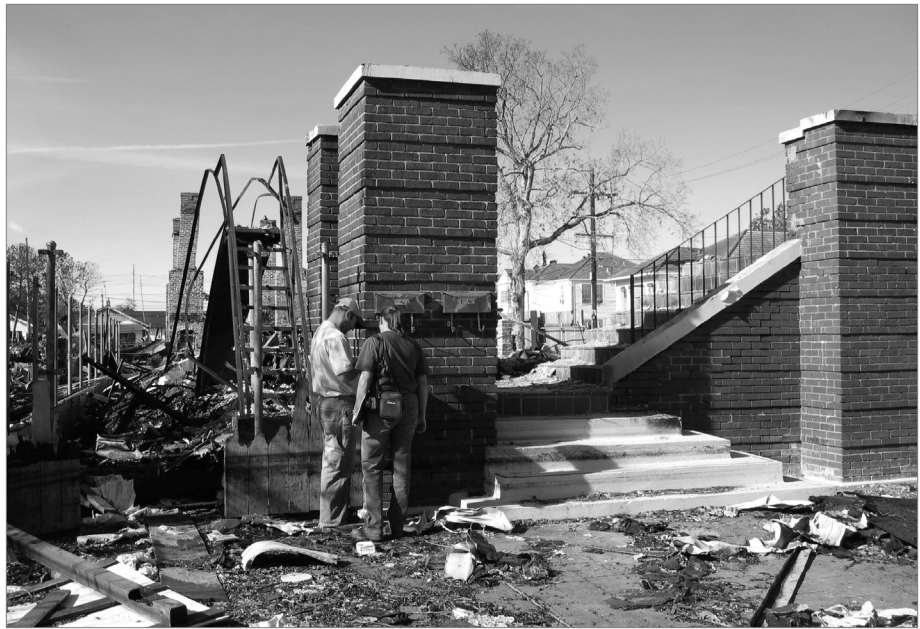
FEMA surveyors conducting the red-tag survey of buildings in New Orleans following Katrina, using a hand held GPS unit, Dec. 2005.

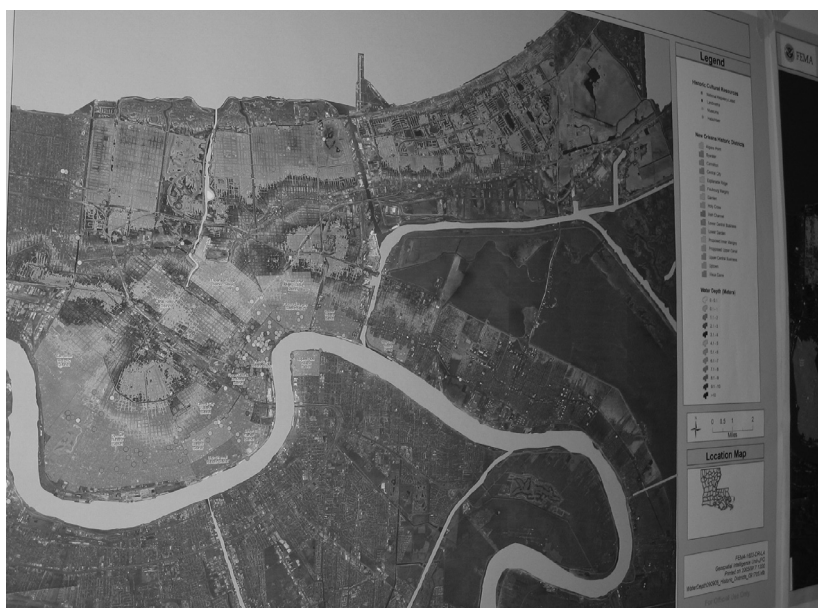
An example of a map produced by the FEMA GIU showing the regions of flooding in New Orleans, Dec. 2005.

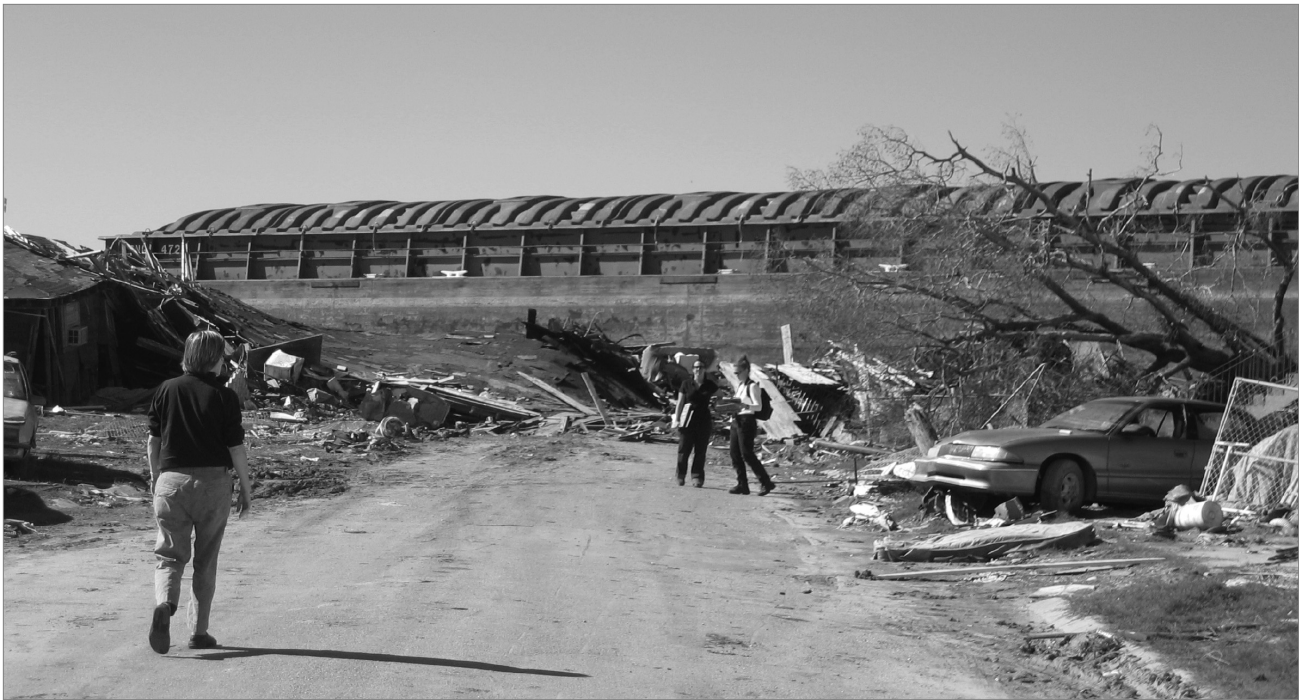
FEMA surveyors conducting the red-tag survey of buildings in the Lower Ninth Ward of New Orleans following Katrina, Jan. 2006.

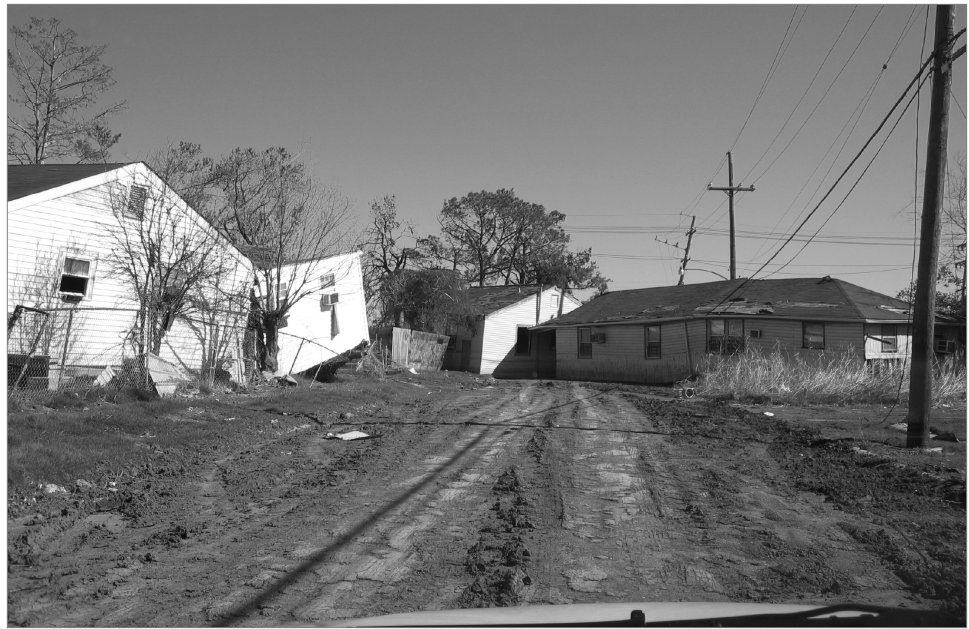
An example of the challenges in accessing resources, moved by the flood waters and often covering roads in the Lower Ninth Ward of New Orleans, Jan. 2006.

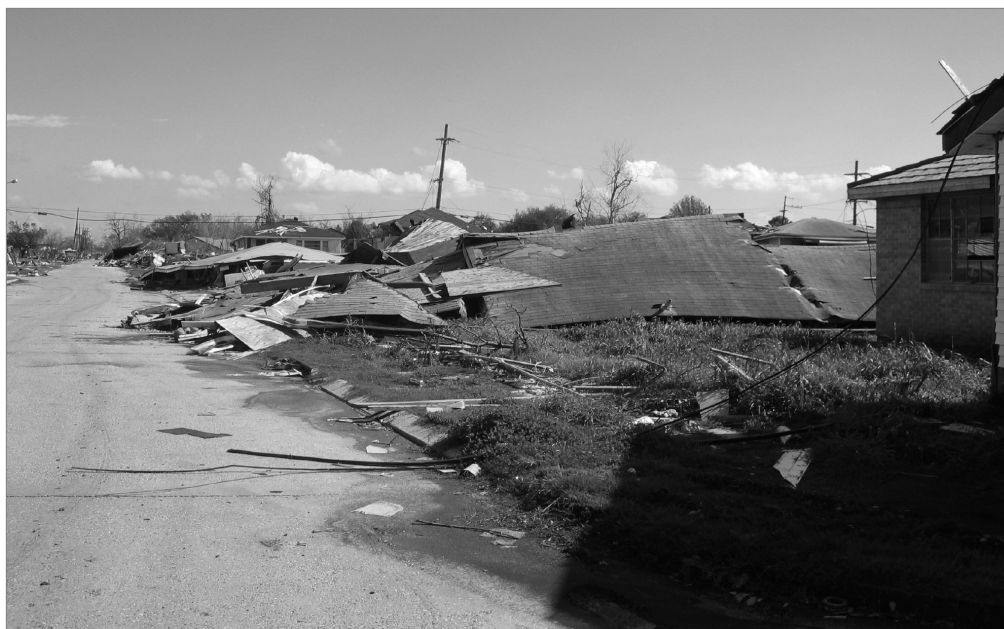
An example of the challenges in identifying resources often moved off of their original foundations or collapsed as a result of flooding in the Lower Ninth Ward of New Orleans, Feb. 2006.

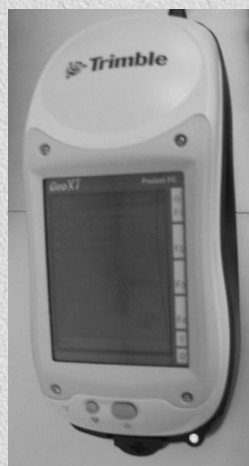
- ✱ Leave the GPS Unit in its cradle to keep the battery charged
  - ◆ The unit is constantly keeping time (even when it is “off”) and it will drain the battery
  - ◆ The battery should last all day without needing a charge under normal circumstances
- ✱ Settings have already been made on the GPS receiver and through the data dictionary itself
  - ◆ No data will be collected from a satellite with a signal strength below 6
  - ◆ No data will be collected from a satellite that is below 15 degrees on the horizon
  - ◆ No data will be collected when you have fewer than 4 satellites that meet these criteria
  - ◆ No data will be collected when your PDOP is above 6

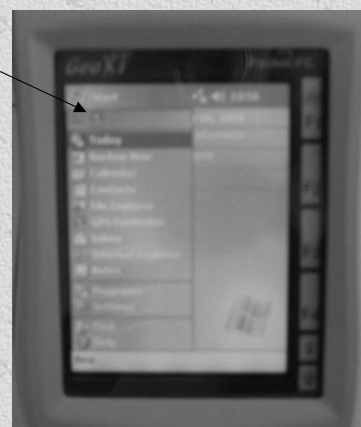
Start menu

Power button

- ✧ When Terra Sync opens you will see the Skyplot view
  - ✧ This indicates what satellites are visible, what their signal strength is, and what your PDOP is
- ✧ You can always return to the Status/Skyplot while in the field recording data if you find the receiver is not recording data for some reason
- ✧ Once you have acquired enough satellites you can begin collecting data

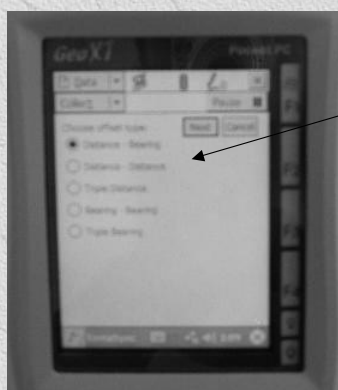
✱ Under the “Options” button menu you will find the Offset function while you are collecting a feature (point, line or polygon)

- ✱ Here you can estimate a distance and provide a compass bearing to offset the point from where you are to the building or resource you need to document

Choose Distance-Bearing after selecting Offset
